IAEA
International Atomic Energy Agency

REPORT OF THE

SAFETY REVIEW

High Flux Reactor

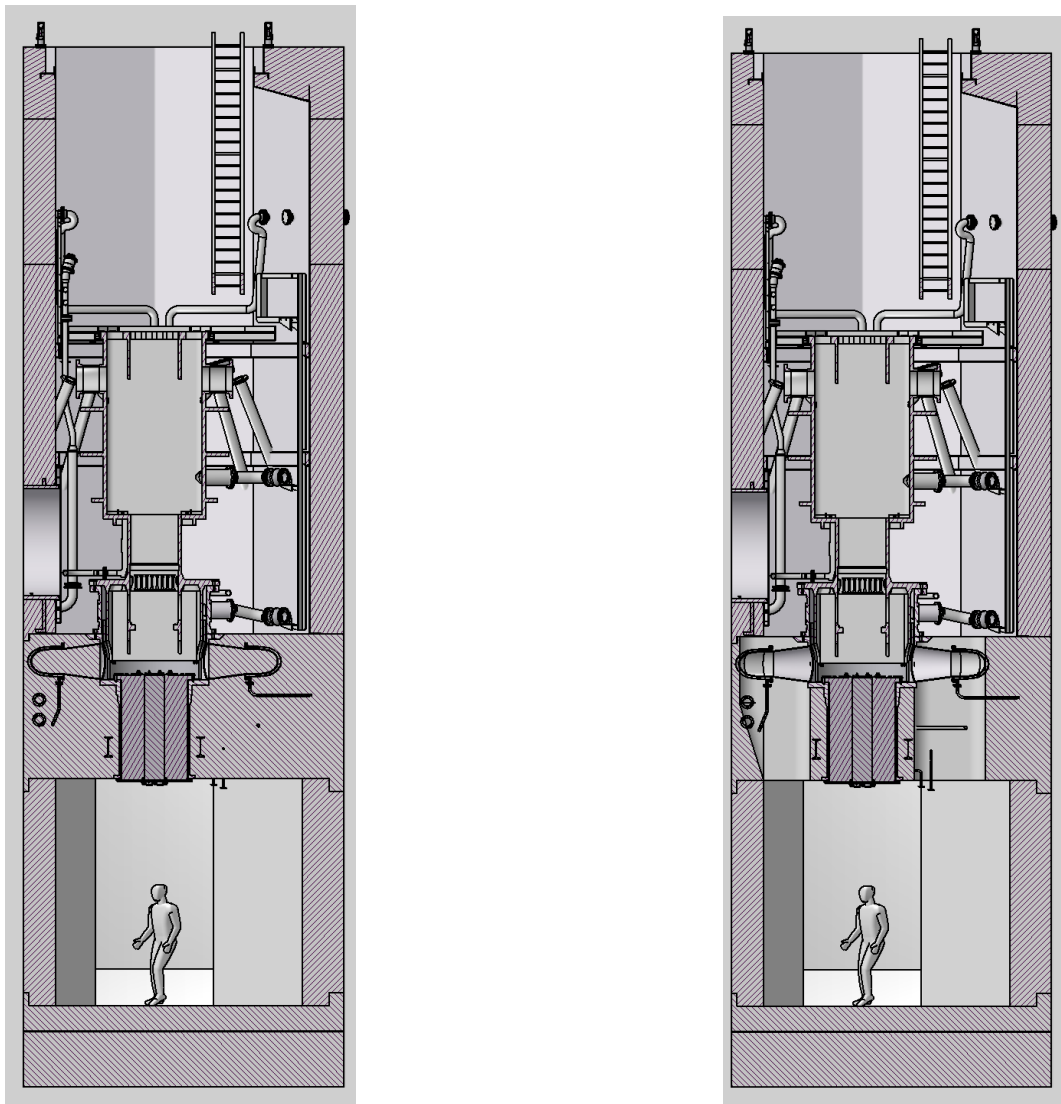
The choice between these options will be made after removal of the concrete surrounding the reducers and detailed inspections to characterize the condition of the reducers. Figure 2 shows simplified cross-sectional views through the reactor vessel and the sub-pile room. The left hand side shows the situation before the reducer repair and the right hand side shows the situation after removal of concrete around both reducers.

FIG 2: Cross-section through the Reactor Vessel and the Sub-pile room.
Left: Shows situation before reducer repair
Right: Shows situation after removal of concrete around both reducers

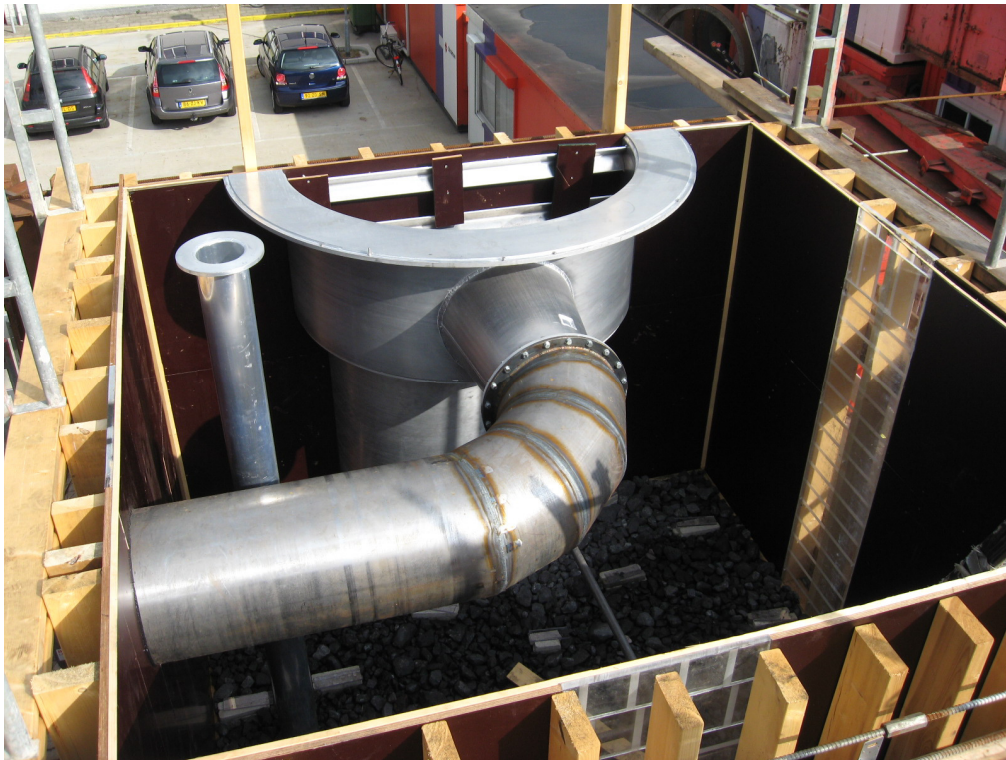
FIG. 3: Mock-up of reducer prior to pouring concrete.

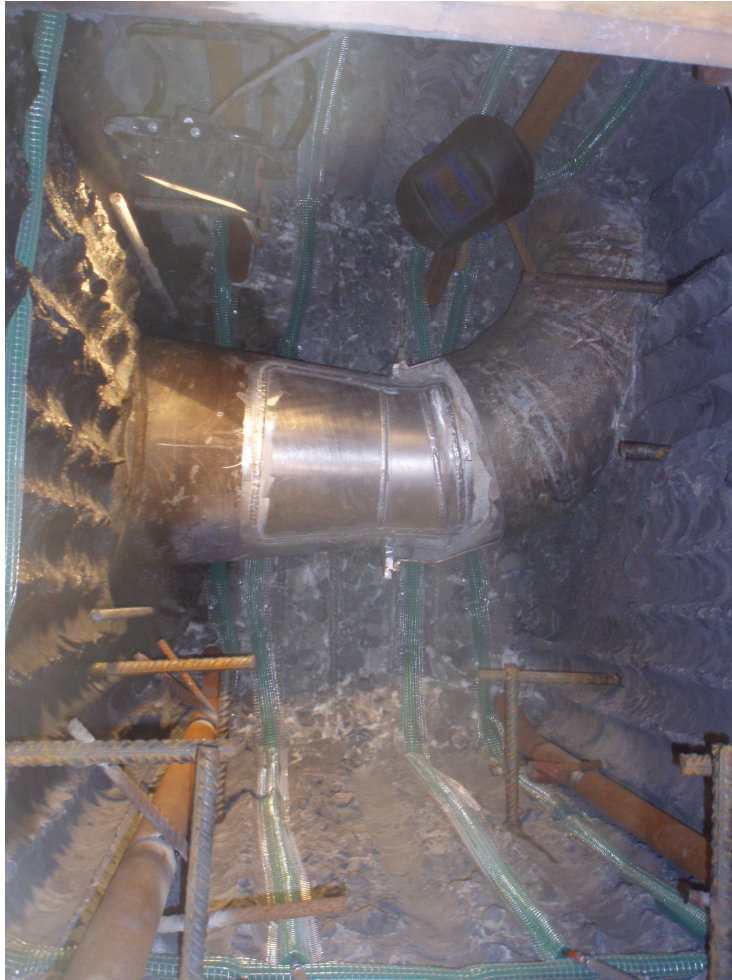
FIG. 4: Mock-up of reducer after a test patch weld repair of the reducer.
