DUTCH
SAFETY BOARD

Fatal loss of control accident with a Pipistrel Alpha Electro near Stadskanaal airfield

The Hague, July 2020

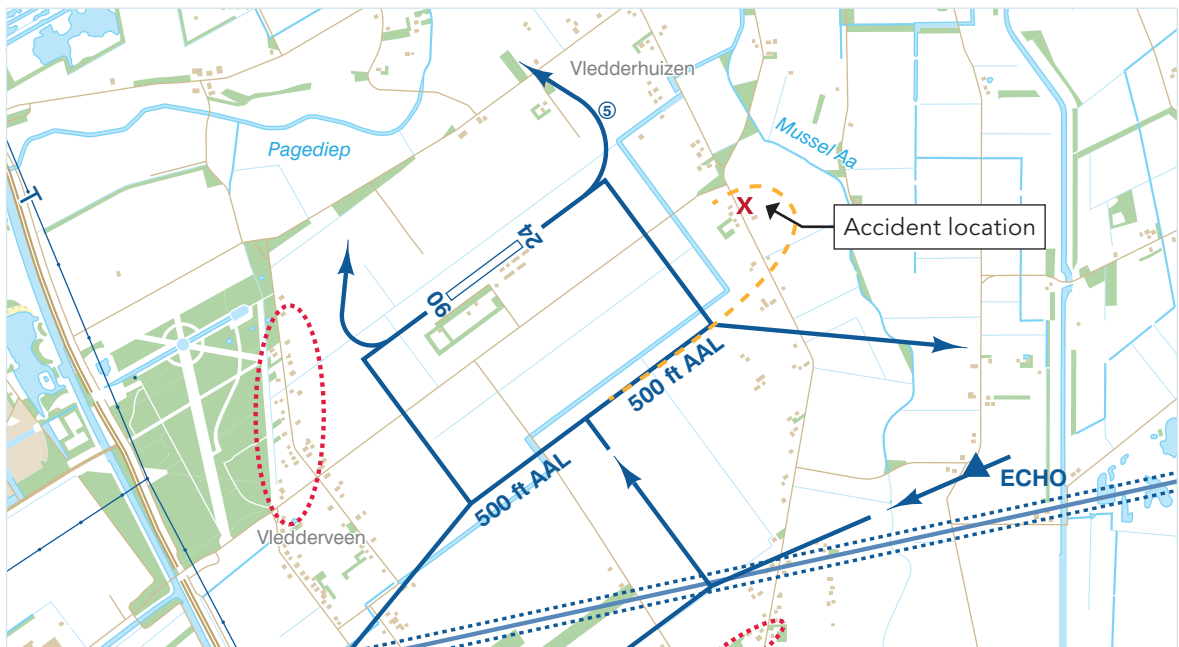
Figure 3: Accident location. (Source: EHST Visual Approach Chart, AIP the Netherlands)

As depicted in Figure 3, the location of the crash was outside the circuit area.

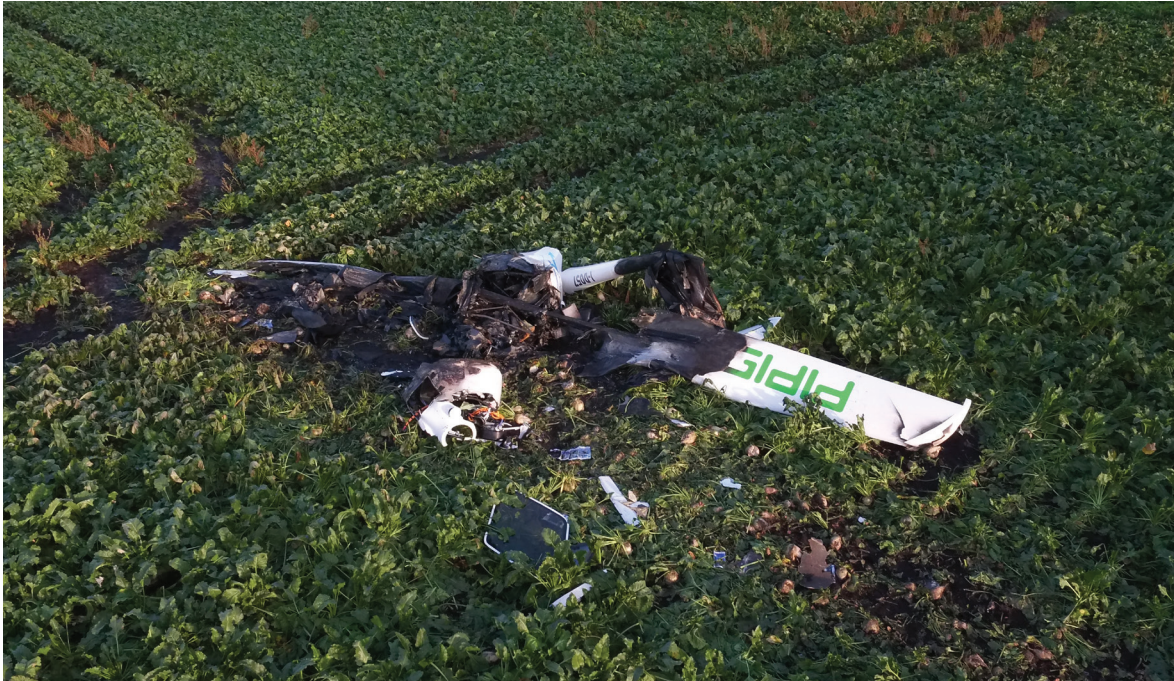
Figure 4: Wreckage of the aeroplane. (Source: Dutch Aviation Police)

The aeroplane was destroyed as a result of the crash and the post-impact fire, see Figure 4.

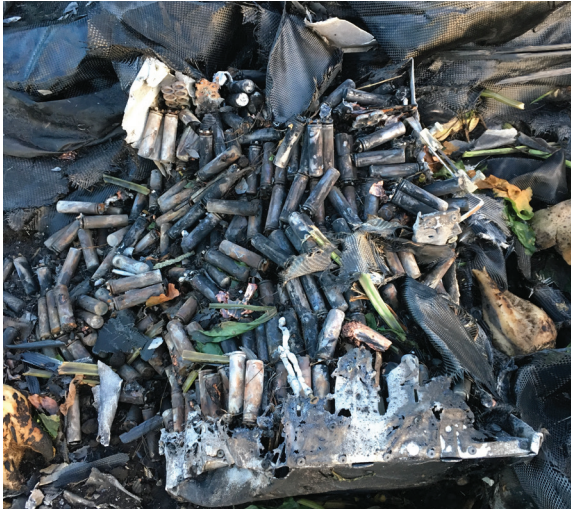
Figure 9: The burnt-out front battery pack.

Shortly after the aeroplane impacted the ground, a fire started under the right wing. This fire was caused by the damaged front battery pack which was forcefully ejected from the front battery compartment during the crash. The front battery pack was burnt-out completely, see Figure 9. The rear battery did not catch fire; it was found fully intact in the aft fuselage, see Figure 10.

The front battery burnt-out completely, after it had been ejected from the front battery compartment during the crash. Neither the compartment of the front battery nor the electrical connection cable (of the front battery) showed signs of fire, which indicates that the whole battery pack started burning only after separation from the fuselage, i.e. after the impact. It was concluded that the battery most likely caught fire because of an internal short circuit as a result of physical damage during impact.

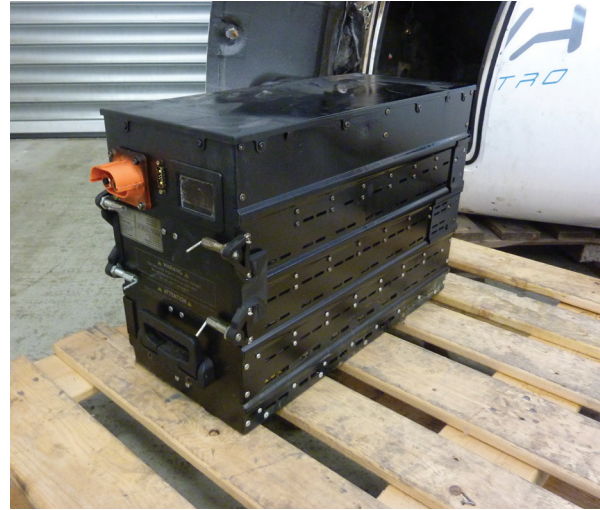
Figure 10: The intact rear battery pack.

The rear battery pack was found fully intact in its compartment inside the aft fuselage. Although parts of the fuselage around the battery compartment were damaged by fire, the rear battery compartment showed no signs of fire damage. Inside the battery, signs of smoke and dust, which entered through ventilation openings, were present. The battery management system was visually inspected and found damaged, probably as a result of water used to extinguish the fire. The individual cells were measured: 86 out of the 96 cells were found in a normal voltage range. Ten cells were found below their normal voltage range. With normal voltage range is meant that the voltage of the cells corresponded to the duration of the flight.²⁶ In contrast, the battery management system display indicated a battery state of charge of 0% and a state of health of 90%. The cause of the difference between the state of charge indicating 0% and the measured voltages, which are indicative for approximately 50% capacity of the battery, has not been established. One possible explanation for the difference is that the state of charge is always based on the cell with the lowest voltage. This means that only one cell needs to be empty to have a state of charge indication of 0%. Another possible explanation is that the cells discharged during impact. This is possible in two ways. Either the battery management system was damaged during the impact and discharged the cells or a short circuit caused by dust or water that entered the battery post impact, discharged the cells.

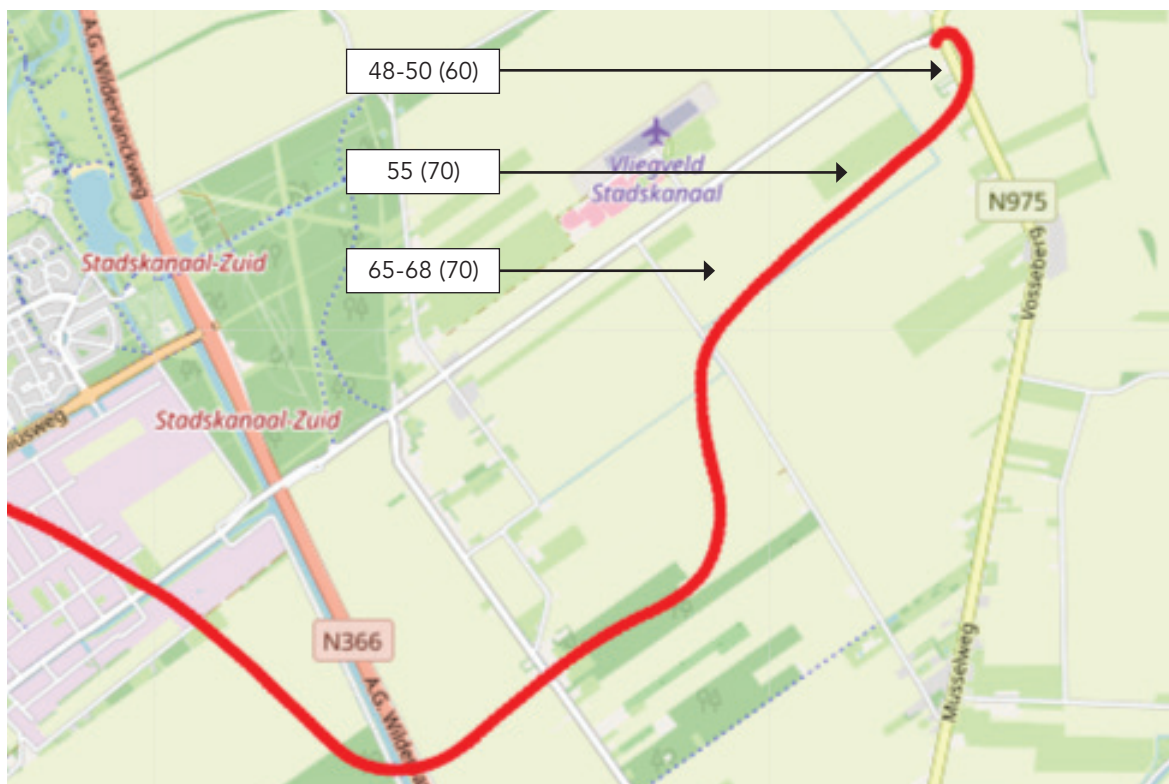
Figure 11: The last part of the flight; actual and prescribed (between brackets) airspeeds in knots. (Source: ATC the Netherlands and OpenStreepMap)

Flight data shows that at the beginning of downwind, the aeroplane was flying airspeeds between 65 and 68 knots IAS. At the end of downwind, the airspeed had reduced to 55 knots IAS. After turning from downwind to base leg, an airspeed of 48 to 50 knots IAS was recorded and a varying left bank angle. When these actually flown airspeeds are compared with the prescribed³³ airspeeds of 70 knots IAS (downwind) and 60 knots IAS (base leg), it can be determined that the actually flown airspeeds were below the recommended airspeeds. The lowest measured airspeed from the flight data is 48 knots IAS; this is just 10 knots higher than the aeroplane's stall speed for level flight with flaps fully extended. These low airspeeds together with the left bank angle caused the aeroplane to manoeuvre in the flight envelop close to the stall. As a consequence, the aeroplane was susceptible to enter an incipient spin.³⁴

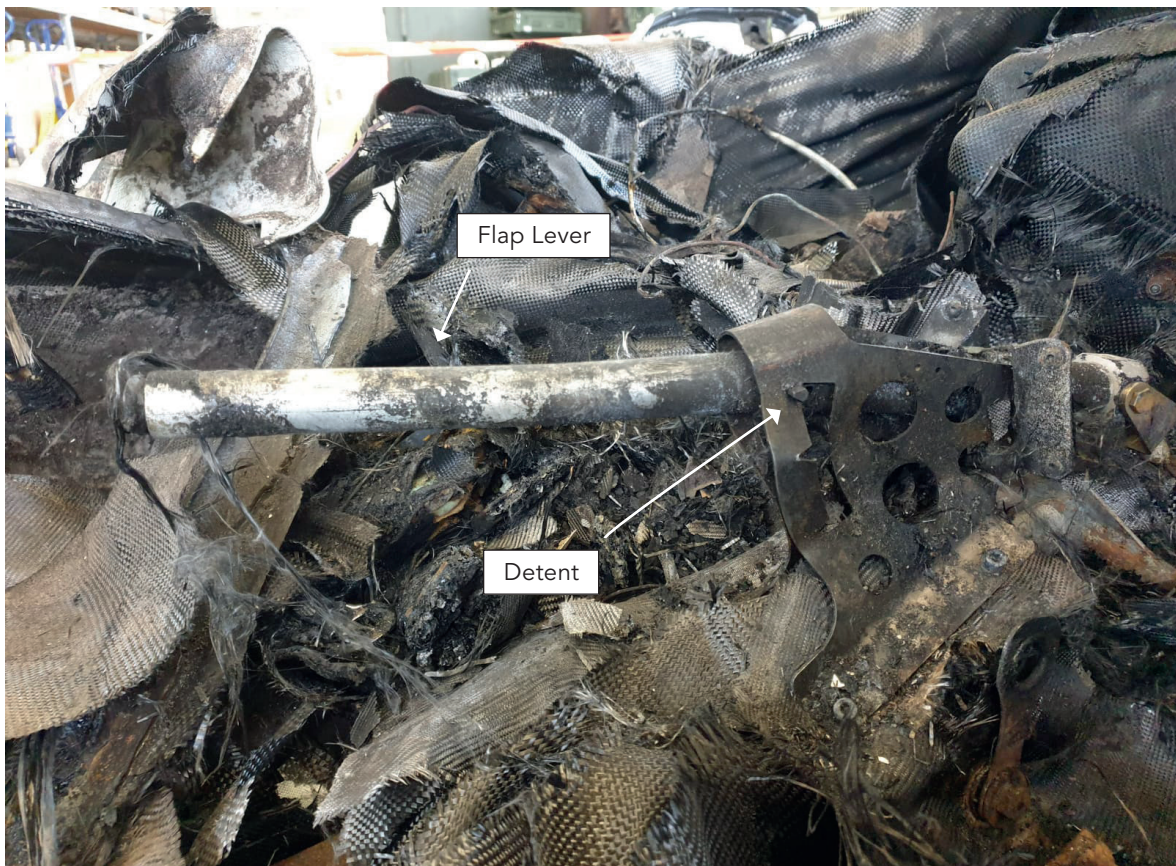
Figure 12: Flap lever set in detent for full flaps.

The aeroplane was found with the flap lever in the +25° ('full flap') position, see Figure 12. This is the configuration for landing. The Pilot's Operating Handbook mentions that the flaps should be selected to +25° on final. With the flaps fully extended (resulting in increased drag forces), the aeroplane is more susceptible to adverse yaw and may therefore require extra attention to rudder coordination. The adverse yaw, which is amplified by the full wing span flaperons of the aeroplane, increased the chance of the loss of control.

Based on the lever construction, it is unlikely that the lever position was changed by the forces of the impact. The actual position of the flaps at the moment of the impact could not be determined, because of the damaged flaperons and wings as a result of the impact and post impact fire. Because of the flap lever construction, it is assumed that the flaps were put deliberately in the full flaps position. It could not be determined why full flaps were selected before being on final.
