Betreft Reactie op uw Wob-verzoek d.d. 9 september 2021

Rooswijk, Goodwin Sands

Designated Site Assessment:
Archaeological Report

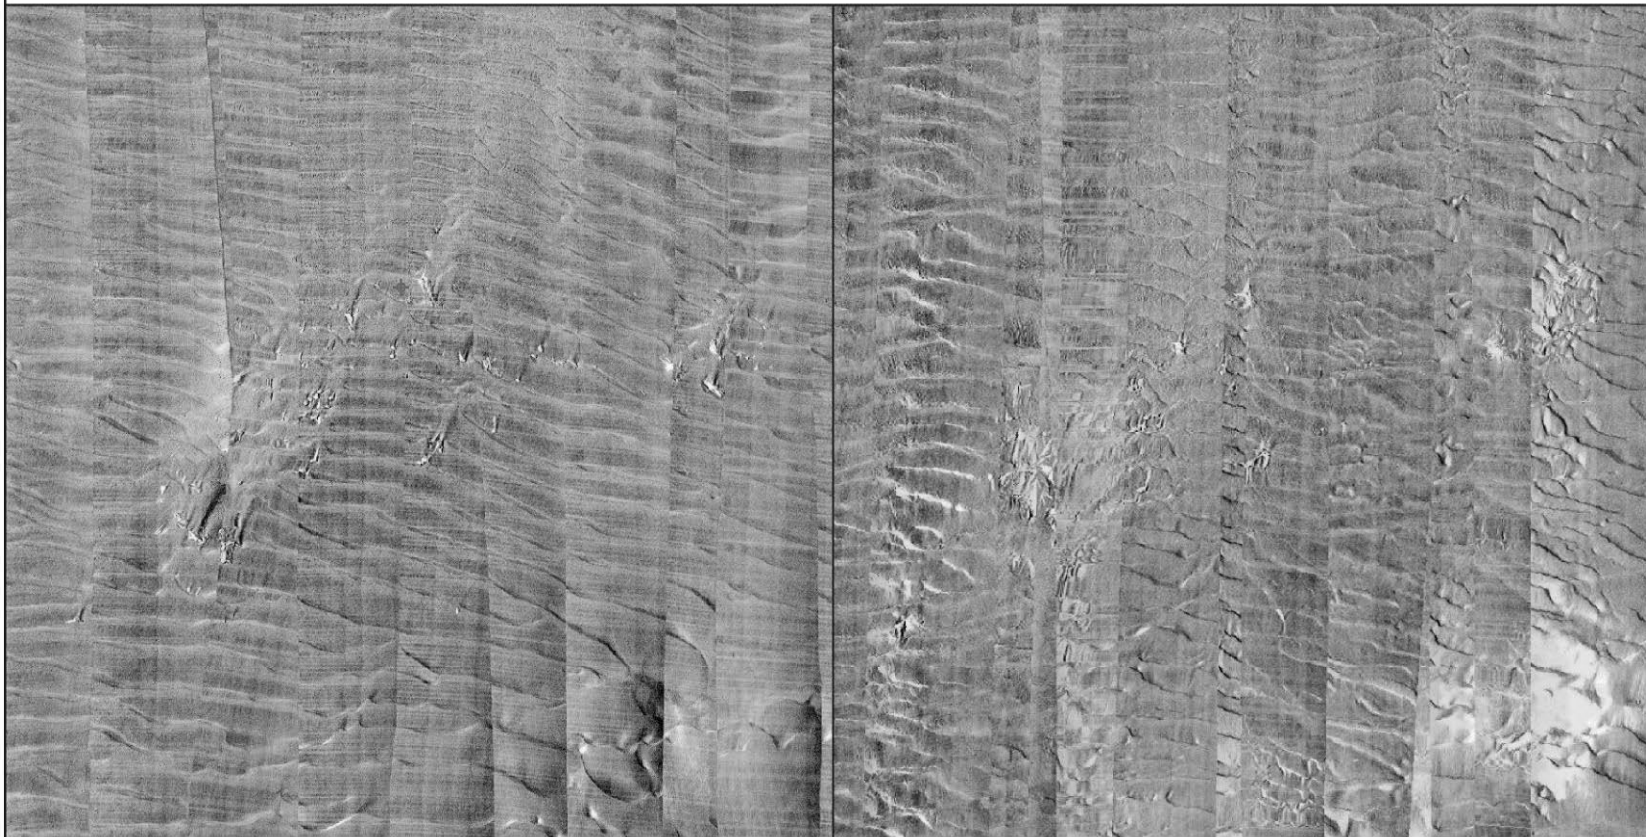
Figure 2

A: 2008 sidescan sonar mosaic

B: 2009 sidescan sonar mosaic

Comparison of 2008 and 2009 sidescan sonar data (West and East Sites)

- 4.2.7. Comparison between the 2008 and 2009 survey data assessed as part of the EEDW project (Wessex Archaeology 2010) further reveal an overall greater exposure of material in 2009 than that interpreted in 2008 (**Figure 2**). The exposure of this material was interpreted by WA as being associated with the erosion of the sand bank immediately southeast of the site. This data is in part supported by observations made by the Licensee, who noted in the 2009 Licensee Progress Report that the northern areas of the middle debris field and East Sites showed increased exposure in comparison to the previous year (Welling 2009). During the 2011 fieldwork session, the Licensee informed WA that wreck related material situated in the eastern extent of the West Site was also exhibiting higher levels of exposure than seen in previous years.

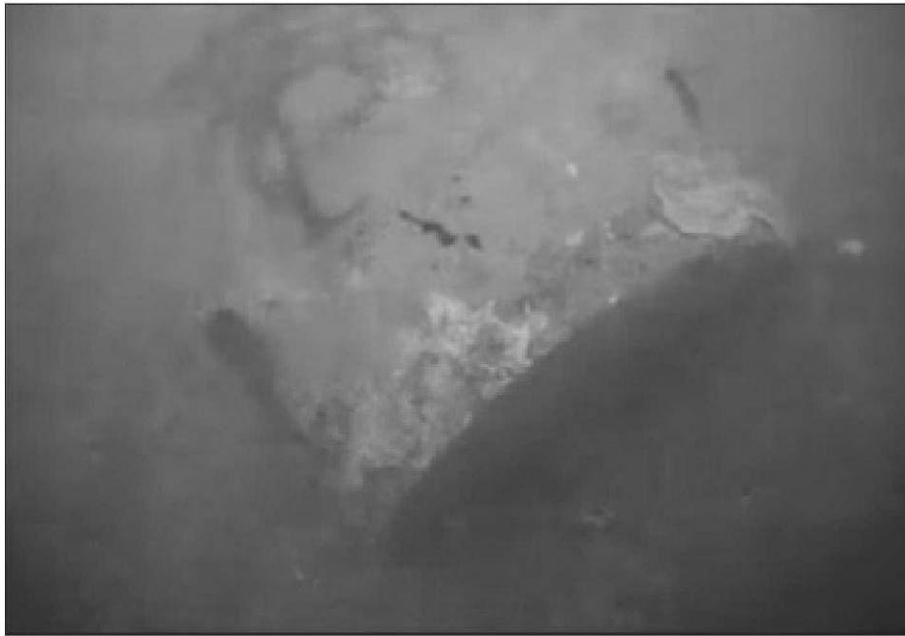
- 4.5.24. The remains of a copper cauldron (**2068**) were observed in the West Site, adjacent to an area of four granite blocks (**2064-7**) (**Plate 1**). The cauldron lay on its side and was partially buried. The exposed surface of the cauldron was slightly flattened and showed signs of damage, with three holes apparent. The base of the cauldron was riveted and was measured to have a diameter of 0.5m. The cauldron measured 0.55m in height.

Plate 1: Copper Cauldron (2068)

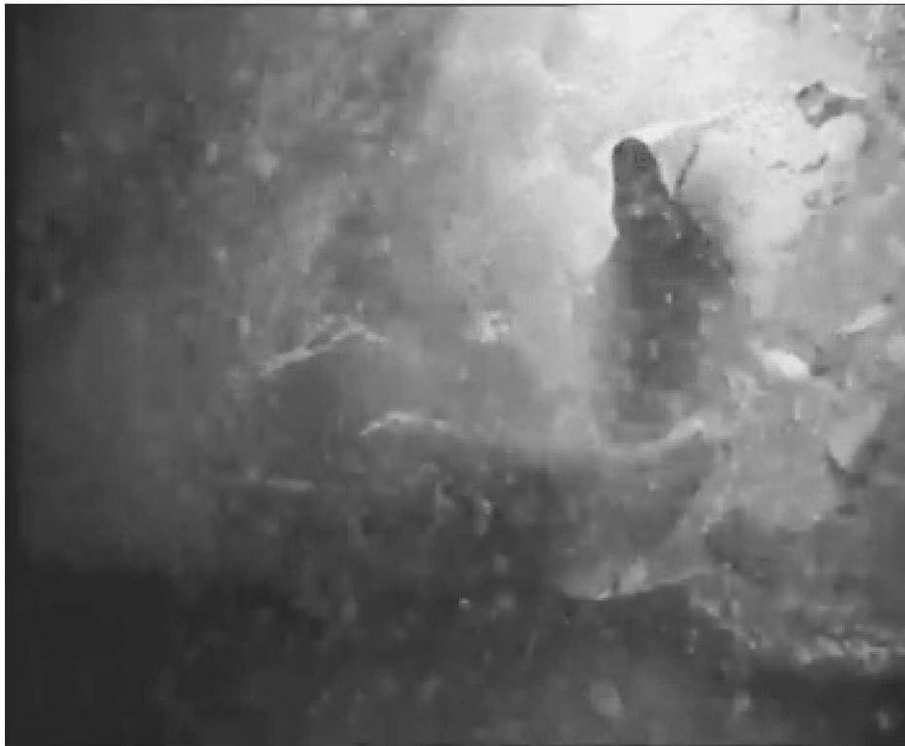
Plate 2: Copper Sheet (2077)

- 4.5.23. Two fragments of cuprous sheet were discovered on the site in 2011. One such sheet was found on the West Site (**2043**), aligned with the outer hull planking of the section of hull structure (**2041**). Although not conclusively identified as such, it is possible that this sheet represents a section of copper sheathing. A further cuprous sheet was also discovered on the East Site (**2077**) (**Plate 2**), adjacent to granite block **2072** and timber **2078**. No discernible features were observed on this section of copper sheathing and as such its original form and function remain unknown.
