Environmental impacts associated with the planned expansion of Karel's Beach Bar, Bonaire

October 2011

By Dr Mark Vermeij

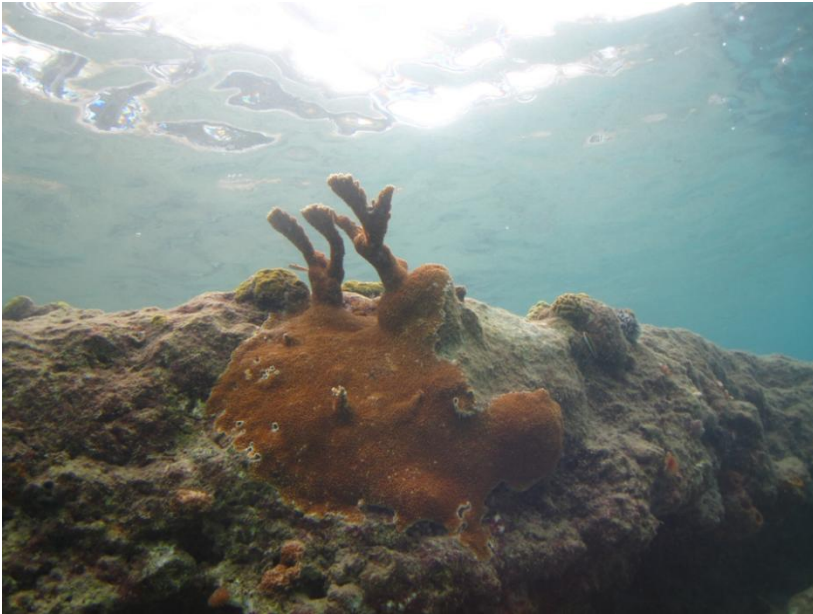
Figure 3. A small colony of the coral *Acropora palmata* growing on a shallow ledge near the proposed construction location. While large colonies are not very abundant, many juvenile colonies were observed growing on the same ledge.

The second area that is of ecological importance is the ledge³ directly bordering the waterline. This area, though small, comprises the following ecological values: (1) it provides suitable substrate for the endangered coral *Acropora palmata* (Elkhorn coral; **Figure 3**), (2) it provides habitat for the most important Caribbean herbivore, the sea urchin *Diadema antillarum*, a species that experienced a massive Caribbean wide mortality event in 1983 and now is now slowly recovering (**Figure 4**) and (3) it serves as a nursery for juvenile fish especially grunts that seek shelter under the aforementioned ledge (**Figure 5**).

Regarding the first, it needs to be noted that although adult colonies of *A. palmata* are relatively rare at the planned construction site, many juveniles of this species (i.e., colonies < 1cm

in diameter) were observed on the ledge. This species is listed as “threatened” throughout their distributional range (i.e., including Bonaire) under the US Endangered Species Act since 2006. In 2008, the National Marine Fisheries Service (NMFS) and the National Oceanic and Atmospheric Administration (NOAA) determined that in order to protect *A. palmata*, its habitat should also be protected (Federal Register 2008).

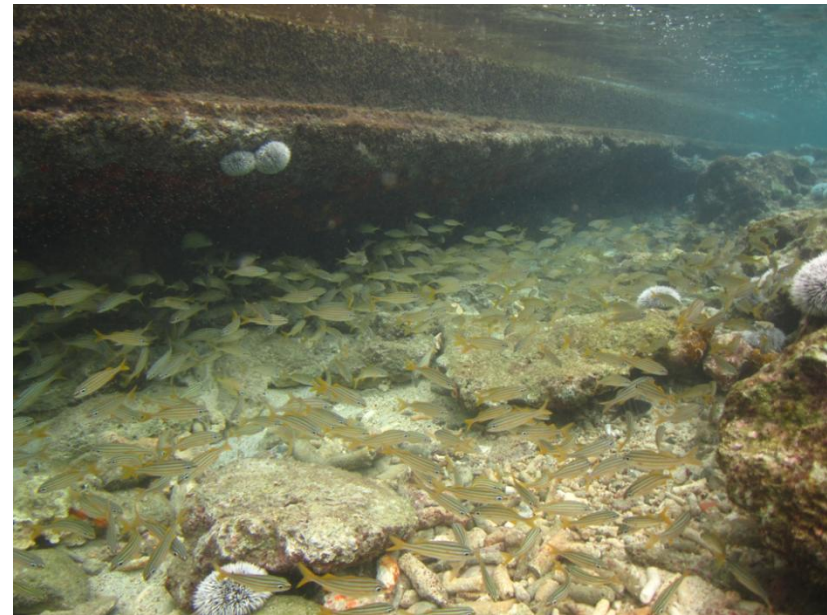
Figure 5. Many fish species such as these juvenile grunts use the ledge mentioned in the text as a shelter or nursery habitat where they escape predation. Reefs bordering such nursery habitats generally harbor larger fish of the same species.

The aforementioned ledge also functions as a nursery for juveniles of at least 12 different reef fish species, many of them commercially important to the reef fisheries (Nagelkerken et al. 2000a, b). Surprisingly, the shelter provided by this ledge therefore acts much like mangroves or seagrasses in which such species normally seek protection. Secondly, the abundance of adults of the same species is shown to be higher on reefs bordering habitats with a “shelter

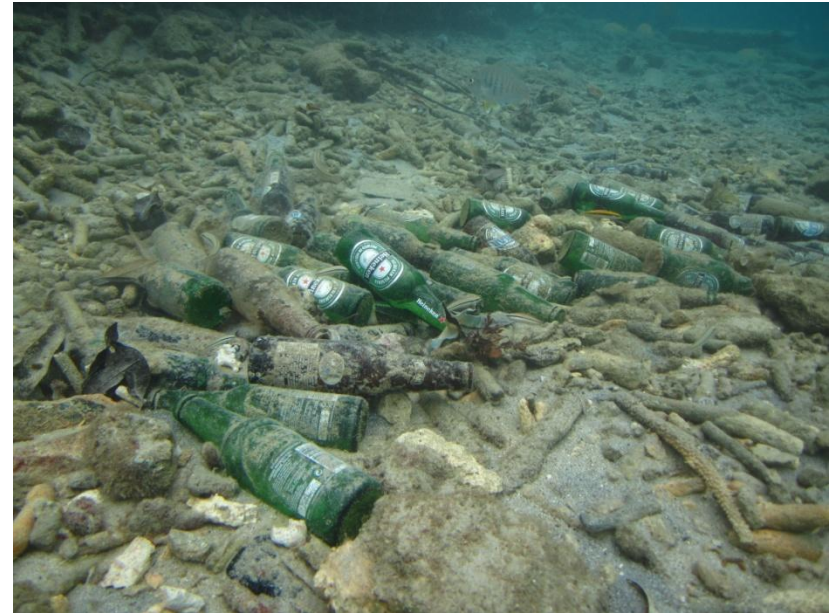
Figure 7. Example of debris that is commonly found around piers.

waste (generated by customers and the restaurant/bar facilities) deserve the utmost attention to prevent these materials from entering the nearby reef waters. Disposal of liquid waste (with sewage being the major concern), should occur by connecting the facilities to the Bonaire waste water system. Any type of liquid waste (including sewage, water used for washing, particulates, organic waste, chemical/ cleaning products, see also "3.2.5. Contaminants from treated wood used for decks") is extremely detrimental to tropical marine communities and can easily affect marine ecosystems downstream of the construction site (where

relatively healthy coral communities are found) as waste easily travels with local currents. It is therefore of paramount importance that all waste generated by the proposed facility (in the broadest sense of the word) does under no circumstances enter the surrounding waters. For a more detailed overview of the effects of commonly used chemicals on coral reef communities, see: Sanchez-Bayo et al. (2011).

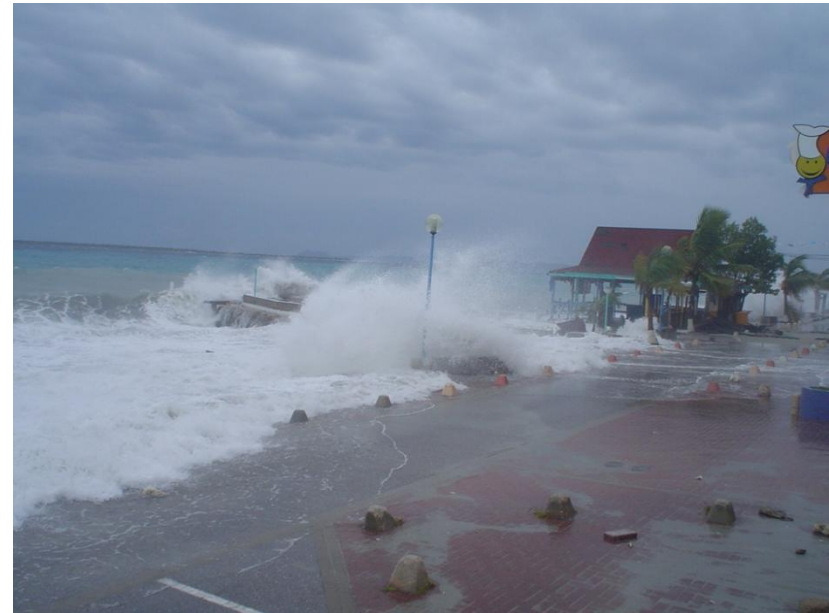
Figure 8. Example of a severe weather event (Tropical storm Omar in 2008) that affected Karel's Bar (shown) directly next to the proposed construction location of the new pier

Experiences from both Bonaire and Curacao have shown that facilities located on piers are generally too weak to withstand occasional severe weather events (**Figure 8**). In the recent past, tropical storms Lenny (1998) and Omar (2008) destroyed a significant number of piers and near shore facilities on both islands. While it is presently unclear whether the proposed facilities are designed to withstand such storms, this matter deserves critical attention. Destruction of all or part of the proposed facilities by a storm will cause a large flux of debris to nearby marine and coastal environments. Such concerns go beyond structural aspects and also include precautionary measures to protect waste water systems etc. from being damaged during such events.
