## Testing deviating bosses on L+G smart gas meters

## Colophon

| <b>Title</b> | Testing deviating bosses on L+G smart gas meters |

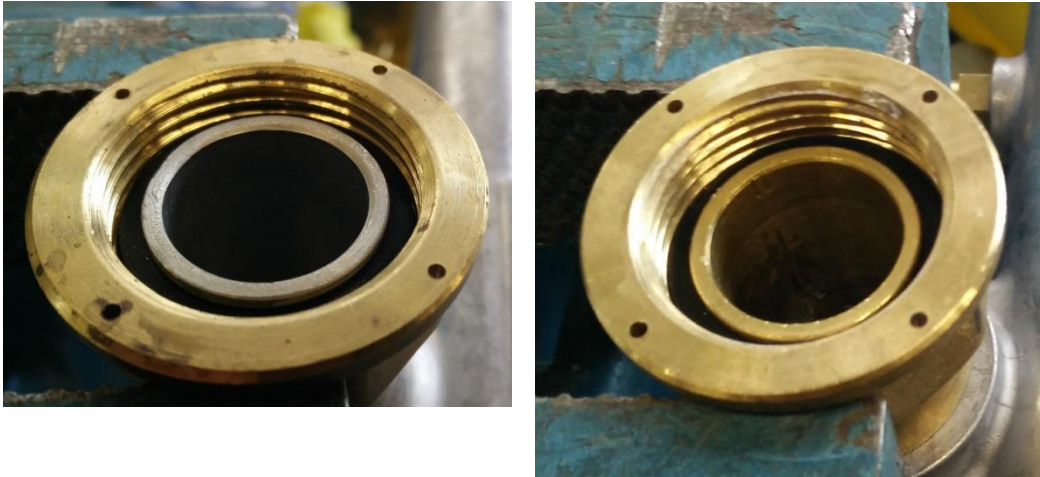
The mounting brackets as these are in use by the grid operators are conforming to Gastec QA requirements KE 165. Comparing different brackets it follows that the thread length available on the nuts differs between bracket designs (but are conforming to KE 165). Especially brackets where spring rings block the nut (left picture) have less thread available. We classify these as sub-optimal in combination with the L+G gas meters with less threading.

Several combinations of L+G gas meters with inadequate threading of the bosses have been combined with different makes of mounting brackets and exposed to severe mechanical stresses (bending, shock and vibration). Mounting brackets that apply a spring ring to lock the nut to the bracket show less available threading on the nut for mounting, but are conforming to the Gastec QA standard KE 165. Combining the inadequate threaded bosses with these brackets results in a mechanically questionable connection.

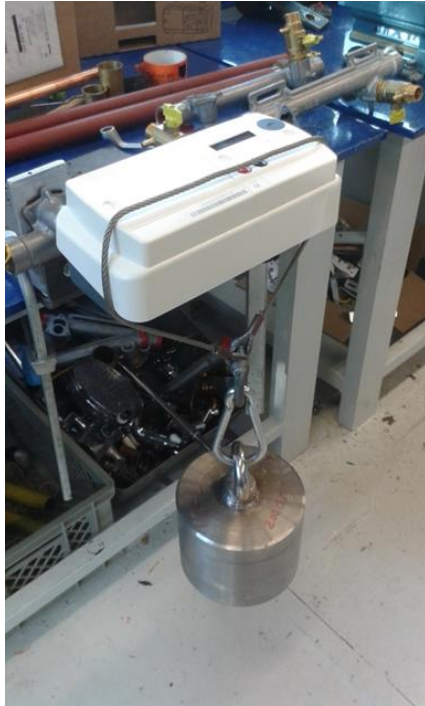
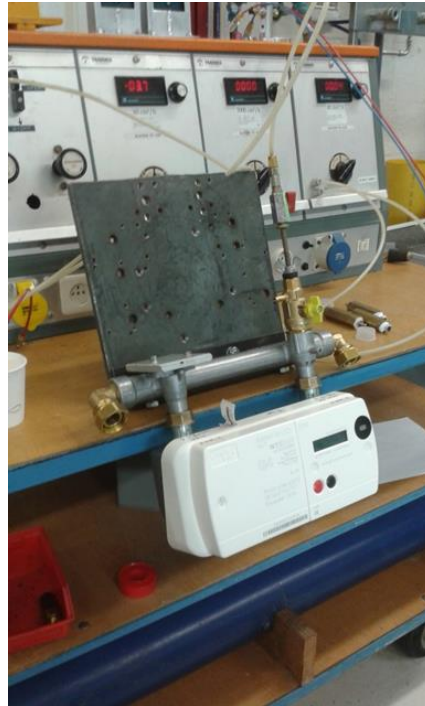
A weight of 40 kgs is put on the meter while it is mounted on a bracket (cranked hand-tight plus 90°<sup>1</sup>). Test according to KE 165, par. 1.10 “Weerstand tegen buigbelasting”.

All tests performed with mounting bracket with spring ring. Leak tests at 300 mbar overpressure.

Left: bending test; right leak tightness test.

The bending tests shows that all tested combinations of meters and brackets withstand the mechanical force and the connections remain tight, even for the worst combinations of bosses and brackets.

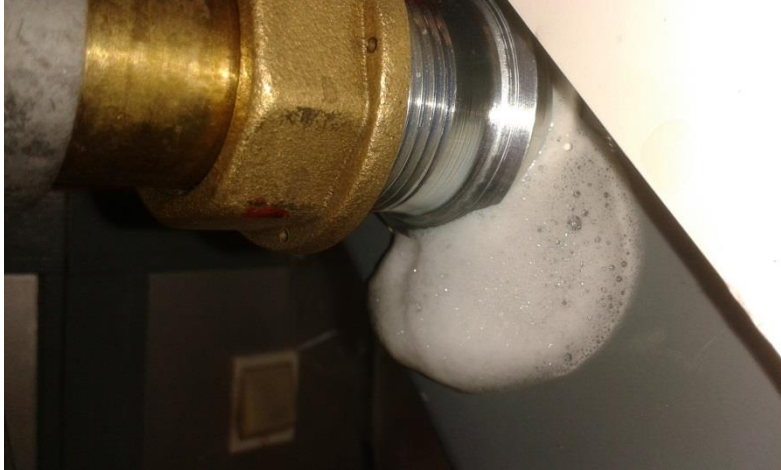
The first test has been started with an OK meter plus OK bracket. This test should confirm that a right combination of gas meter and bracket can withstand the test. Unfortunately the test has been halted (because of a broken bolt and damage to the bracket) after  $\approx$  3 hours (of the total test time of 20 hours). Due to the extreme stiff mounting the bracket failed. The connections between meter and bracket have been leak tested and proved to be tight. For further testing a new mounting rig is used, resulting in a more flexible mount.

The first test (test 1A) (that was halted because of a broken fixing) has been restarted. The result after 20 hours was that the connections were both leak tight, but the fixing of the bosses in the meter housing were leaking.

The vibration test was imposed to two samples of OK meters and OK brackets to provide evidence that a sound mounting of gas meter and bracket will withstand the test. The outcome is positive, except for the finding that the mounting of the bosses to the meter housing might be leaking after the test. Applying the vibration test to NOK meters and brackets with spring ring resulted in one case where the nut came lose in about one hour. Retightening the nut by cranking to almost 180° instead of normal 90° resulted in leak tight connection after the test.

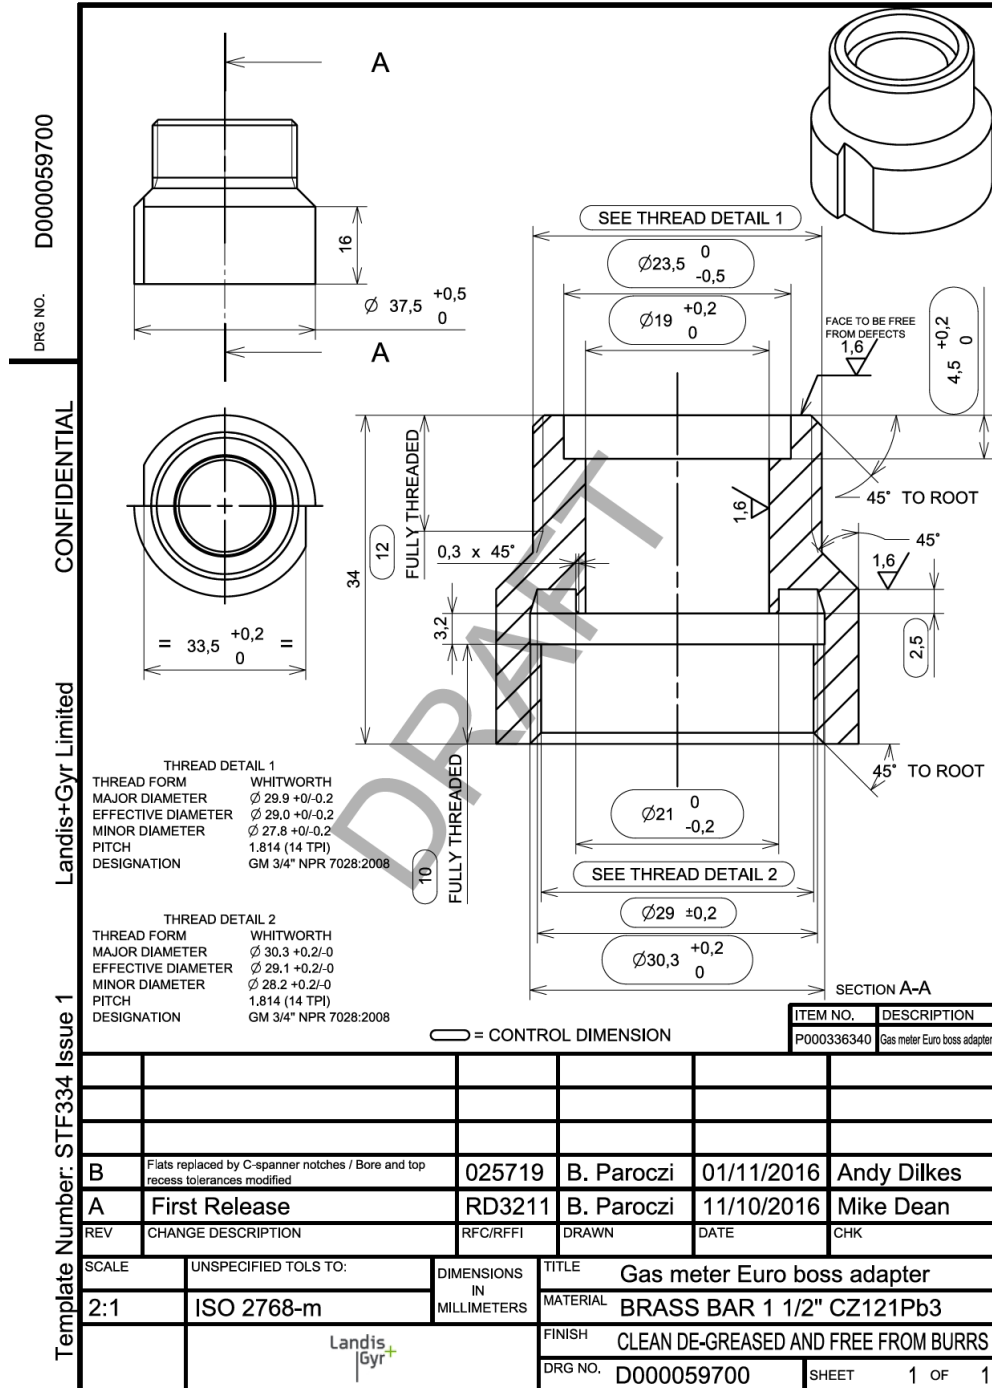
L+G has designed an adapter to apply to the inadequate bosses to provide for adequate thread length, complying to NPR 7028. The 2<sup>nd</sup> version drawing is shown below.

The adapters look well-machined and fit for purpose. The male threads are according to NPR 7028. The female threads have approx. 4.5 full turns to mount the adapter hand-tight on the meter boss (+ 1/4 turn cranking).

The applied gasket dimensions differ from the dimensions in NPR 7028. The outer diameter is 29 (i.s.o. 28) mm and the thickness 3.5 (i.s.o. 2) mm. It is not to be expected that this will change the tightness of the connection, when fitted correctly. Attention shall be given that the rubber quality meet requirements of EN 549, including resistance against exposure to natural gas.

The second design can only be mounted using a C-spanner, intended to prevent unwanted attempt to dismount. (Attempt to dismount will most probably lead to failure of the fixing of the boss to the meter housing.)

With some restrictions (quality control of mounting the proposed adapters), the adapter poses a sound solution to overcome the inadequate threading of the bosses of the meters. The momentum measured to unscrew the adapters on the sample meter was unexpectedly low. For a permanent bond the value should be (much) higher.

To avoid any risk of leaking (by loosening of the nut by vibration or other external forces) occurring over the lifetime of the meters (over 20 years), it is advised to refit the installed meters with the proposed bosses. It is advised to provide for a well designed quality assurance system (fitting instructions, statistical quality checks or 100% leak testing after mounting) for the field mounting of the adapters, to assure leak tightness.

The momentum measured to unscrew the adapters on the sample meter was unexpectedly low. Further attention is needed to selection of the bonding substance.
