IAEA
International Atomic Energy Agency

REPORT OF THE

SAFETY REVIEW

High Flux Reactor

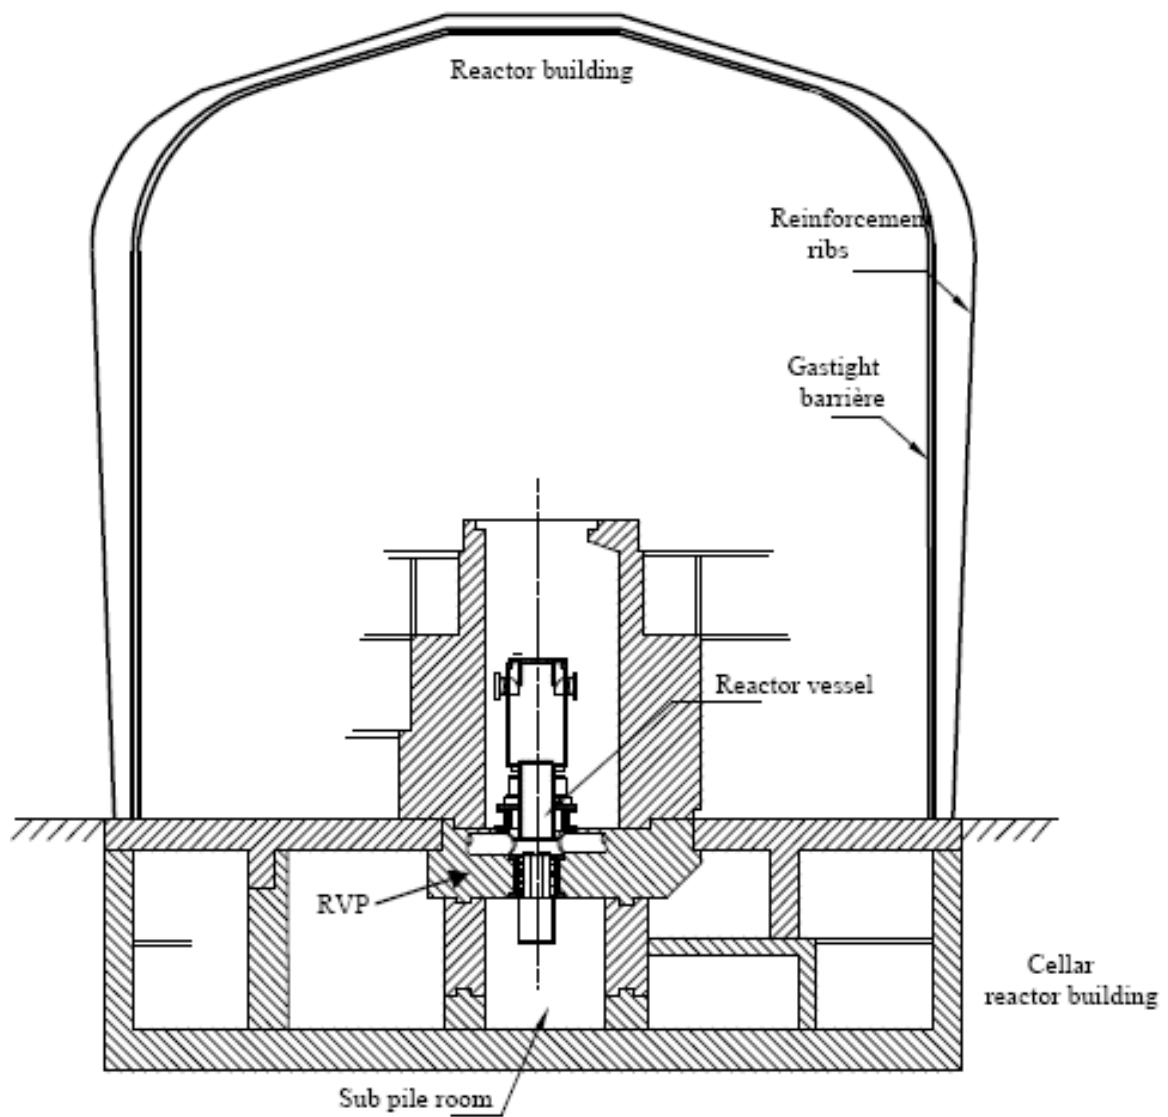
FIG. 1: Simplified Cross-section of the Reactor Building showing location of the Reactor Vessel, the Reactor Vessel Plug (RVP) and the Sub-pile Room

The High Flux Reactor (HFR), Petten is a 45 MW tank-in-pool research reactor, commissioned in 1961. The HFR is the property of the European Commission and is operated and maintained by NRG, who is the license holder of the reactor. Figure 1 gives a simplified cross sectional view of the reactor building, the reactor vessel, the reactor vessel plug (RVG) and the sub-pile room layout.
