DUTCH
SAFETY BOARD

Fatal loss of control accident with a Pipistrel Alpha Electro near Stadskanaal airfield

The Hague, July 2020

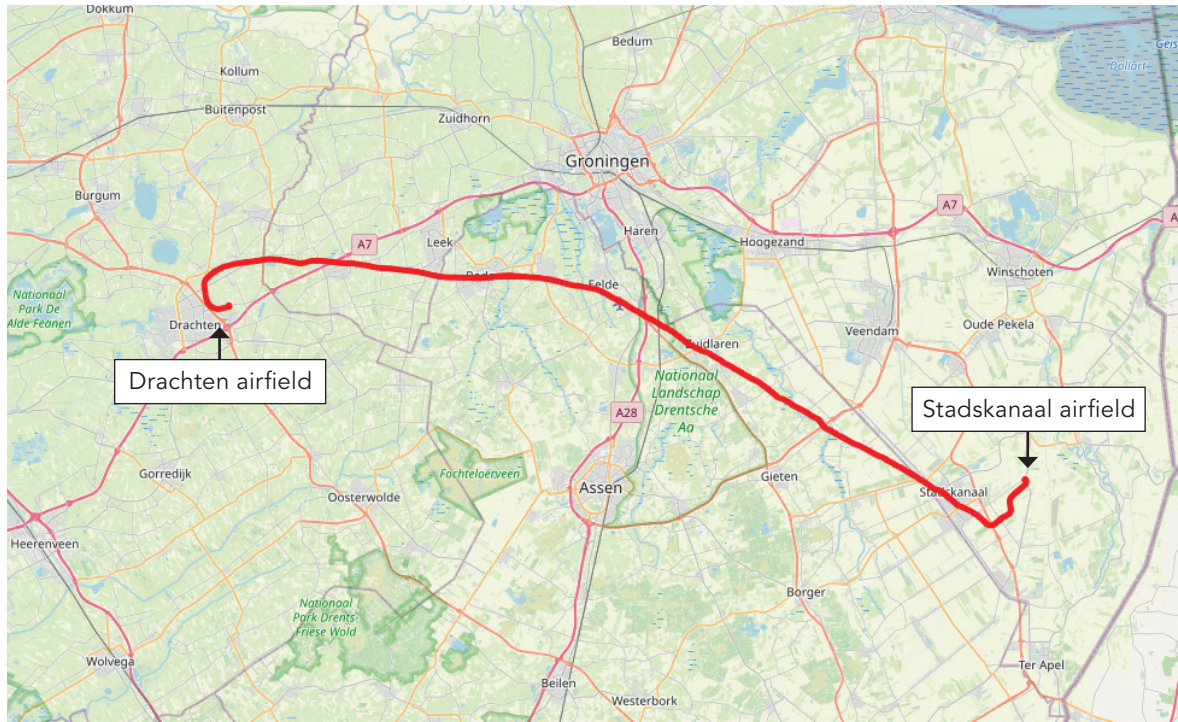
The pilot departed Drachten airfield's runway 26 at 12.12 hours. He made a right turn and set course towards Groningen Airport Eelde. En route, the pilot flew at altitudes between 500 and 1,000 feet AMSL. He contacted Eelde Tower requesting to enter the control zone. After crossing the Eelde control zone the aeroplane flew towards Stadskanaal airfield, see Figure 1.

Figure 1: Flight route of I-D057 (red line). (Source: ATC the Netherlands and OpenStreetMap)

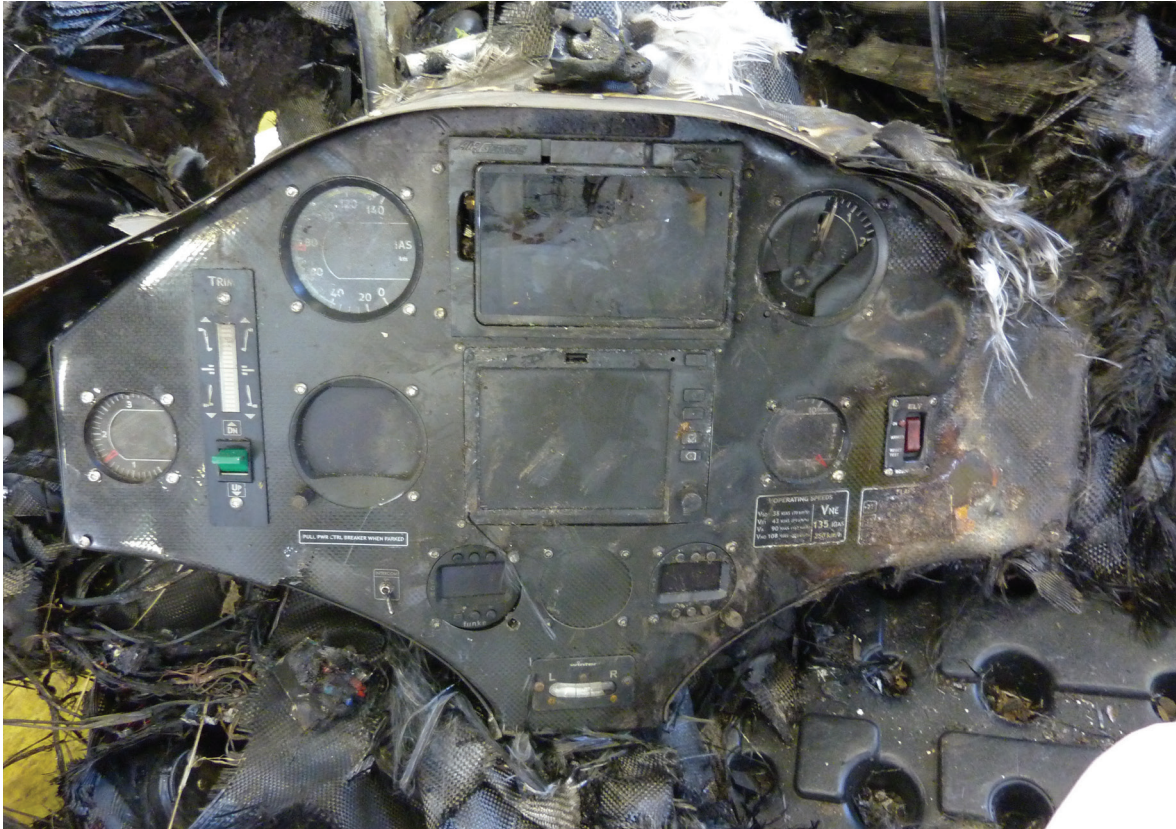
Despite the fact that the aeroplane was largely destroyed by the crash and the subsequent fire, the cockpit instrument panel was partly intact and flight instruments were still readable. See Figure 8. These flight instruments showed the value of the parameters at the time of impact¹²:

¹² The analogue instruments are constructed in such a way that at the moment of impact the needles of the instruments will maintain their present indication.

Figure 8: Instrument panel and flight instruments.

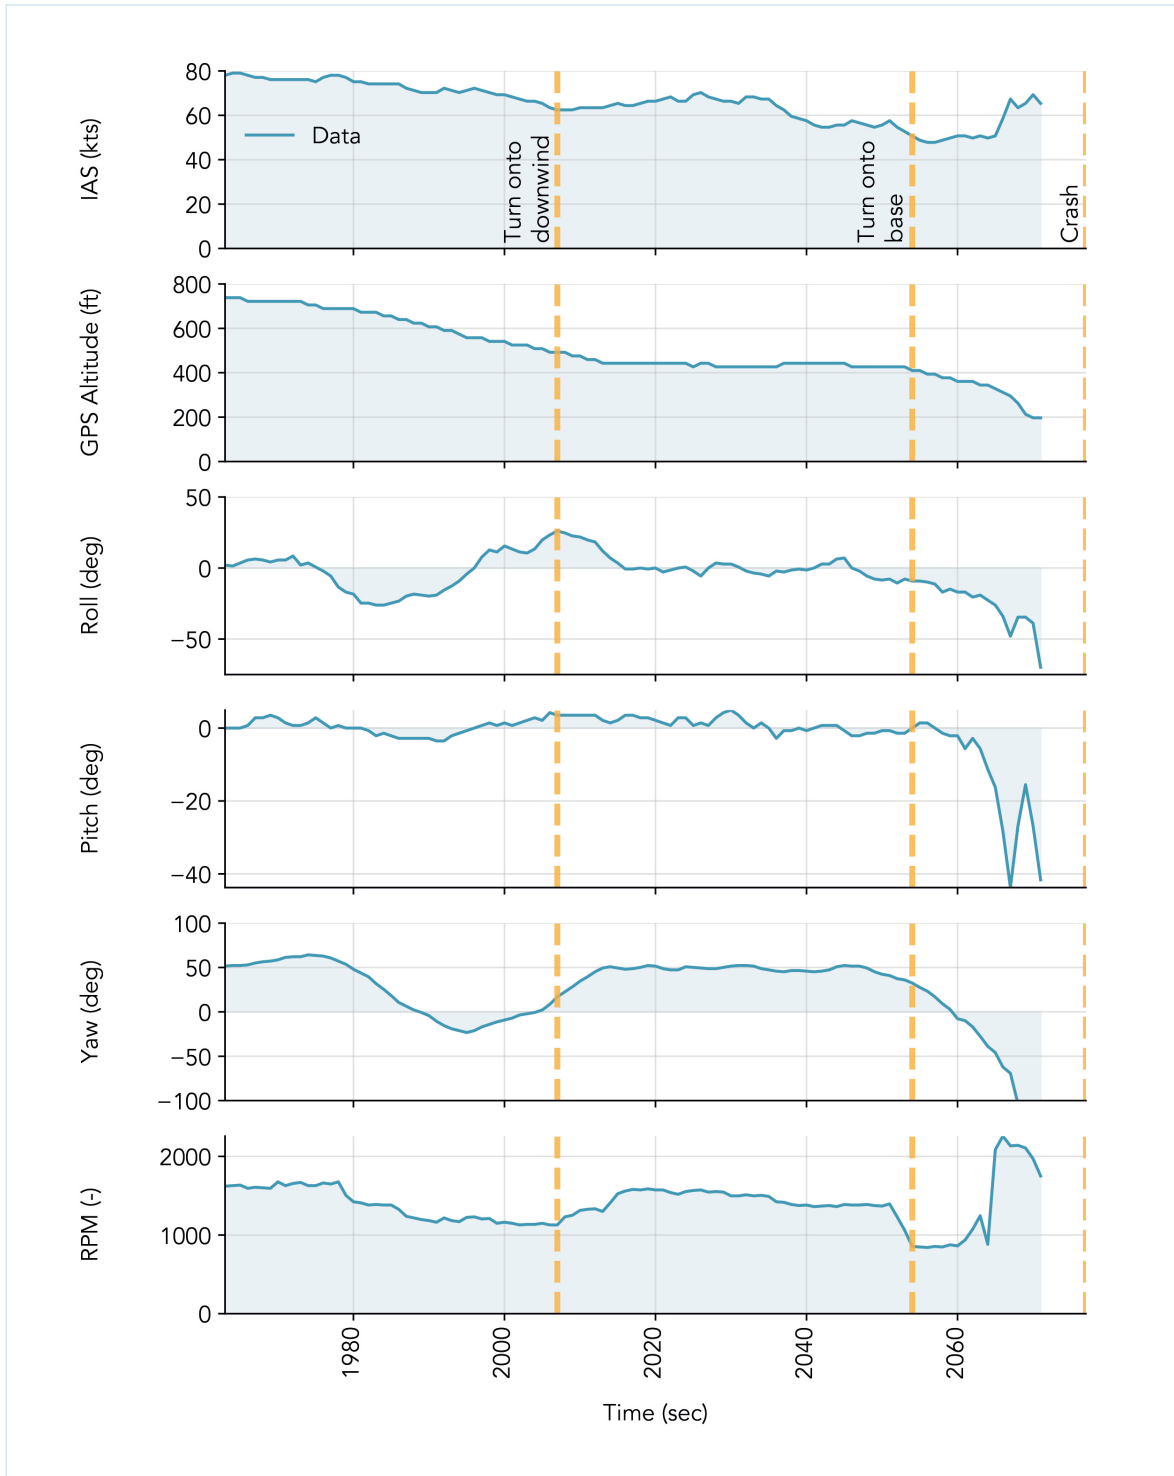
Figure 13: Flight parameters, derived from the altimeter's air data computer.
